EVALUATION OF 1978 REHABILITATION SITES AND EROSION CONTROL TECHNIQUES

REDWOOD NATIONAL PARK WATERSHED REHABILITATION

TECHNICAL REPORT
APRIL 1980

MARY ANN MADEJ,
HARVEY KELSEY, AND
WILLIAM WEAVER

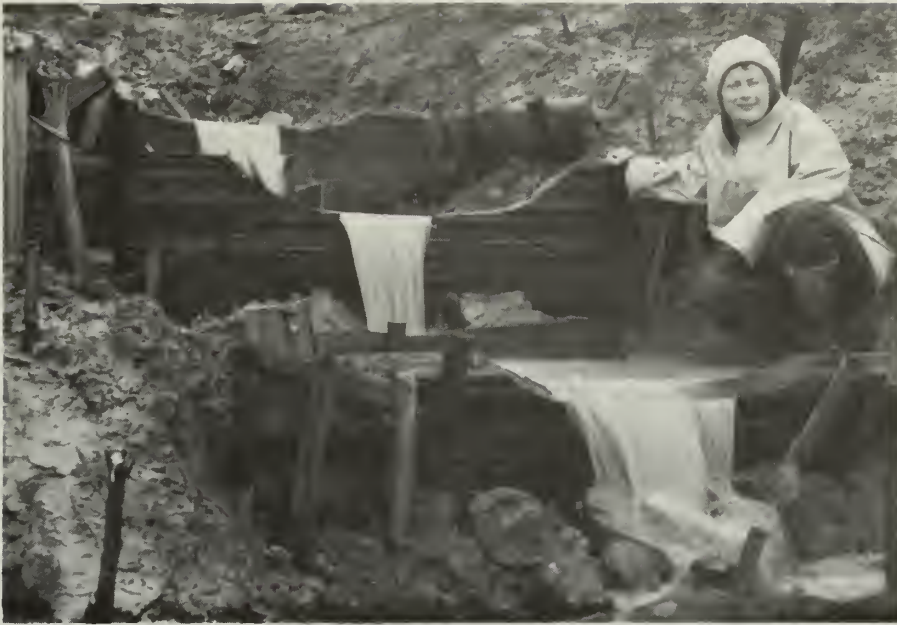
Figure 66: January, 1979
 Miller Creek Unit check dams convey winter flows through broad, high-flow spillways. Large rocks are used as energy dissipators below spillways. Note willow stem cuttings on both channel banks.

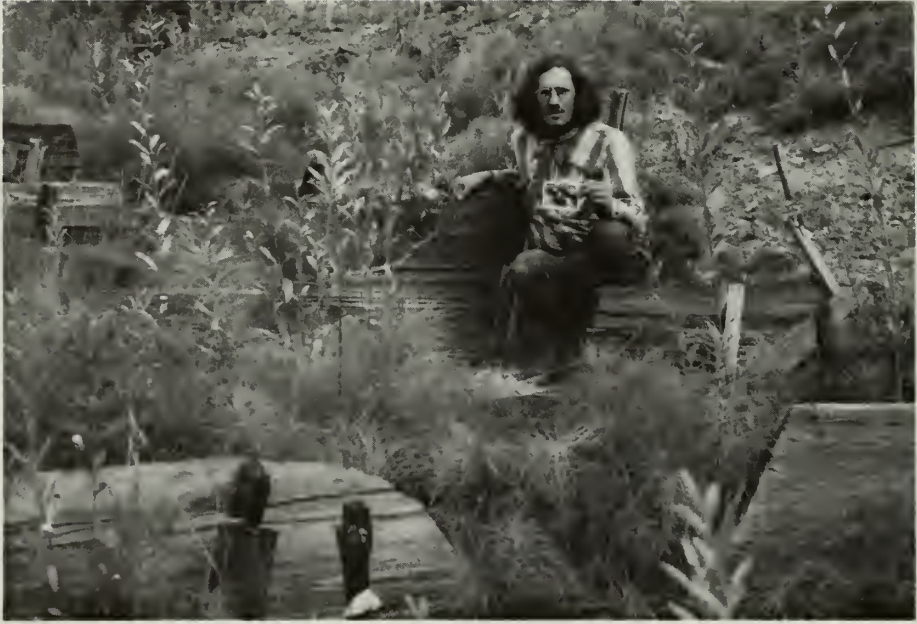
Figure 68: September, 1979
Same series of check dams as figure 66 showing
revegetation after one season. Willow (salix, spp.)
have sprouted from stem cuttings while horsetail
(Equisetum, spp.) invaded naturally.

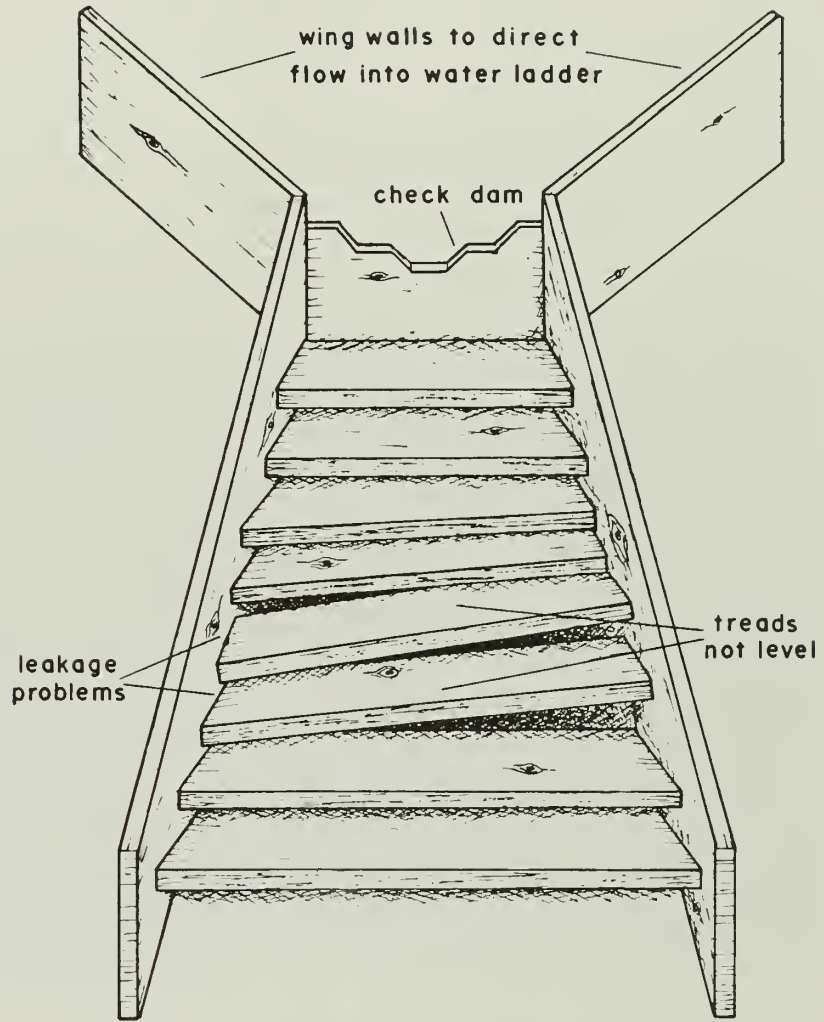
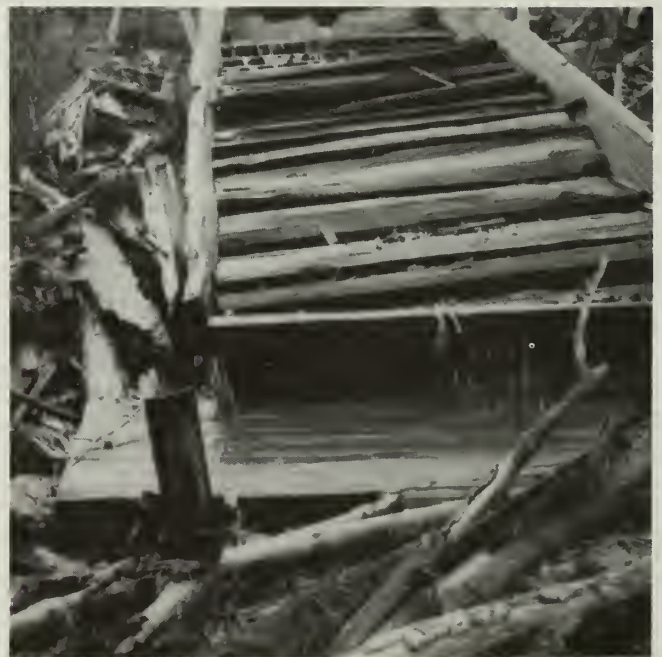
Figure 69:

Three designs of water ladders were used on the Miller Creek unit (see sketches). Type 1 was built of hand-split and hand-sawed redwood slabs. Because of the hand-split wood had an uneven surface, ladder treads were not flush with side pieces, and water seeped through these cracks to flow below the ladder. In addition, ladder treads were not level and water flowed towards the side of the ladder, accentuating leakage problems. Although the knickpoint under the top of the ladder was still protected, undercutting of the ladder would continue and eventually undermine the structure unless leakage problems were corrected. Solutions to the leakage problem include, nailing short slats of wood over and under the treads parallel and flush with the side pieces, caulking all cracks, or cutting grooves on top of the treads to direct low flow towards the center of the ladder. In June, 1979, a CETA work crew repaired the water ladder to prevent further leakage. Figure 69 shows a Type 1 water ladder before repairs were made.

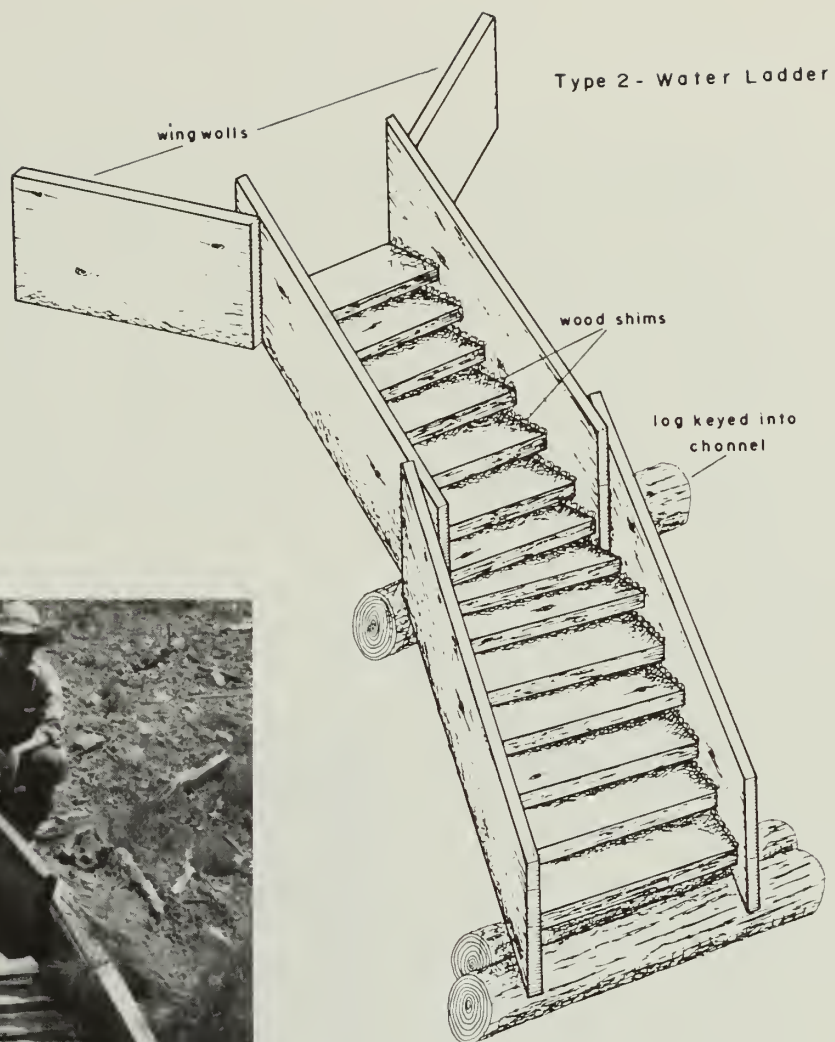
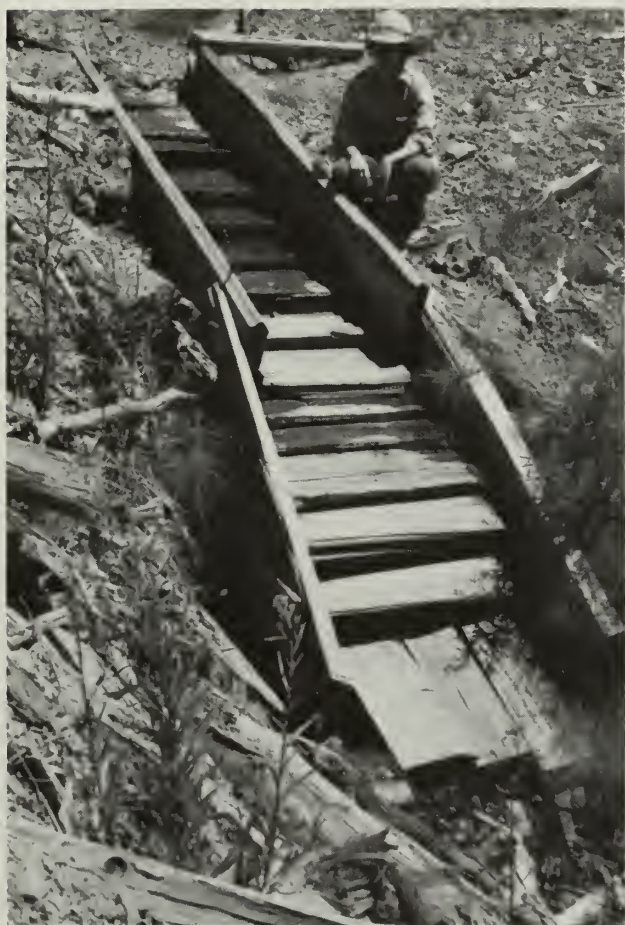
Figure 70: Type 2 Water Ladder

Type 2 water ladder (Figure 70) at Miller Creek is fully functional, and is also built from hand-split redwood. Wing walls above the ladder effectively directed flow over the ladder. The ladder is built in two overlapping sections, conforming to the channel configuration and in-channel debris. The ladder's top tread is keyed into

a partially buried log. Some scour (4 inches deep) occurred upstream of the log, but rocks were deposited in the scour hole. There is little danger of the entire log being undercut. The ladder was large enough for 1978-1979 winter flows; however, a large storm event would probably overtop the structure. Dry wood shims were hammered into all cracks. The shims swelled upon wetting and sealed the seams of the ladder, preventing almost all leakage. The energy dissipator at the foot of the ladder is composed of large logs in the channel (some were already keyed into the channel before the ladder was built). No downcutting occurred below the ladder.

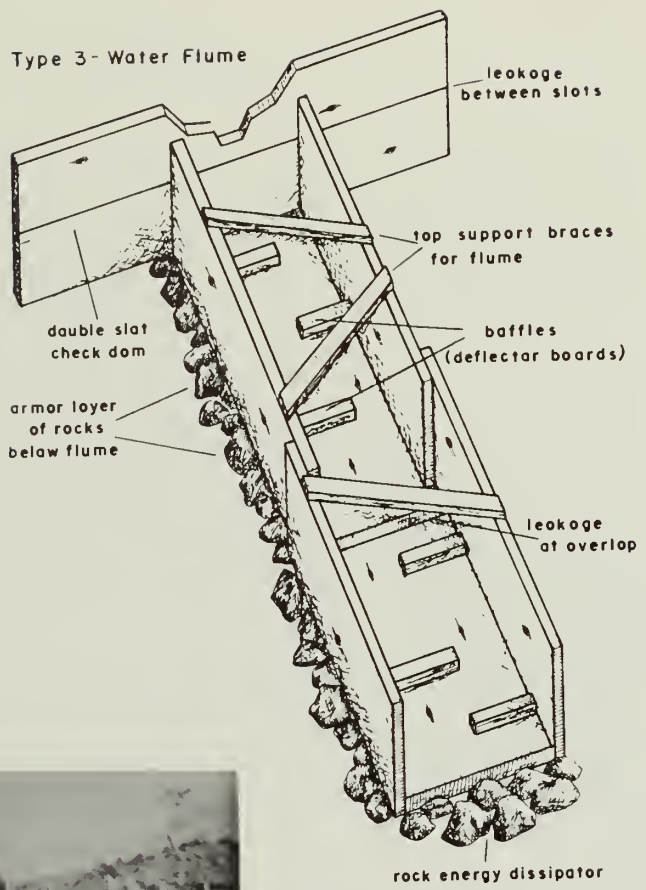
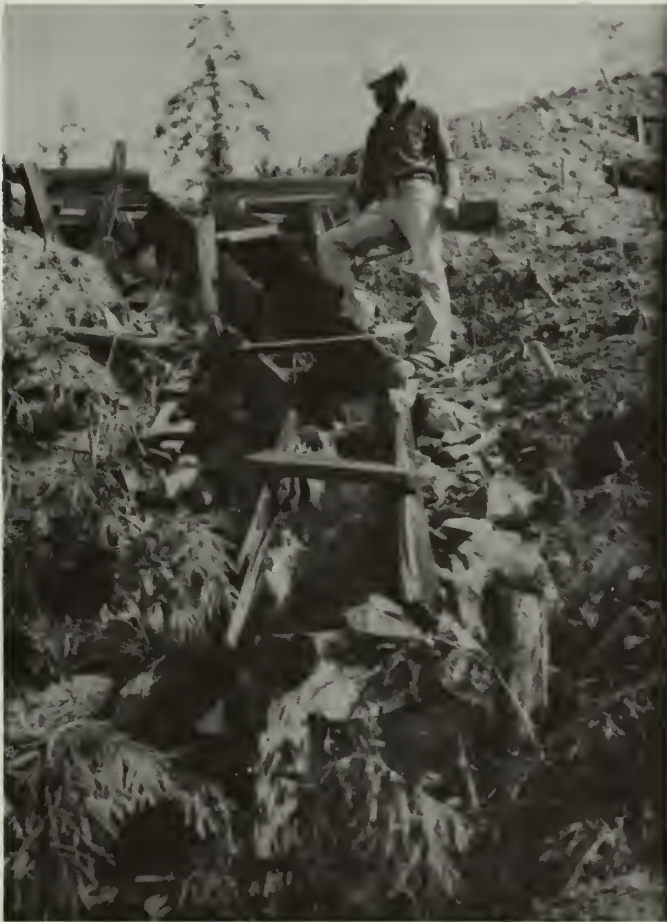
Figure 71: Type 3 Water Flume

Type 3 (Figure 71) was a water flume constructed at Miller Creek from milled redwood slabs. A check dam built at the top of the water flume directed water through its spillway into the flume. A layer of large rocks was used to line the channel bed, and the flume (three 7-foot sections) was installed on top of the rocks. Braces built across the top of the flume add support to the structure.

The Type 3 design developed several problems. Cracks between two slats of the check dam leaked water to the channel outside the flume. The flume's area (18x18 inches) is too small to handle high flows. The rocks under the flume settled and as a result, the flume shifted slightly. The three sections did not overlap adequately, and some leakage occurred. Some baffles or deflection boards in the flume caused water to jump over the sides at high flows. The flume's outlet did not face downstream, but was slightly directed towards the left bank. An energy dissipator of large rocks placed in and around a trash rack was not sufficient to prevent bank erosion below the flume.

To summarize, the most significant problem by far with Type 3 water flume was the small cross-sectional area of the flume that will not accommodate runoff generated by even a 10-year storm event. The flume will probably wash out, creating severe erosion at the break-in-slope and leading to the development of a gully headcut.

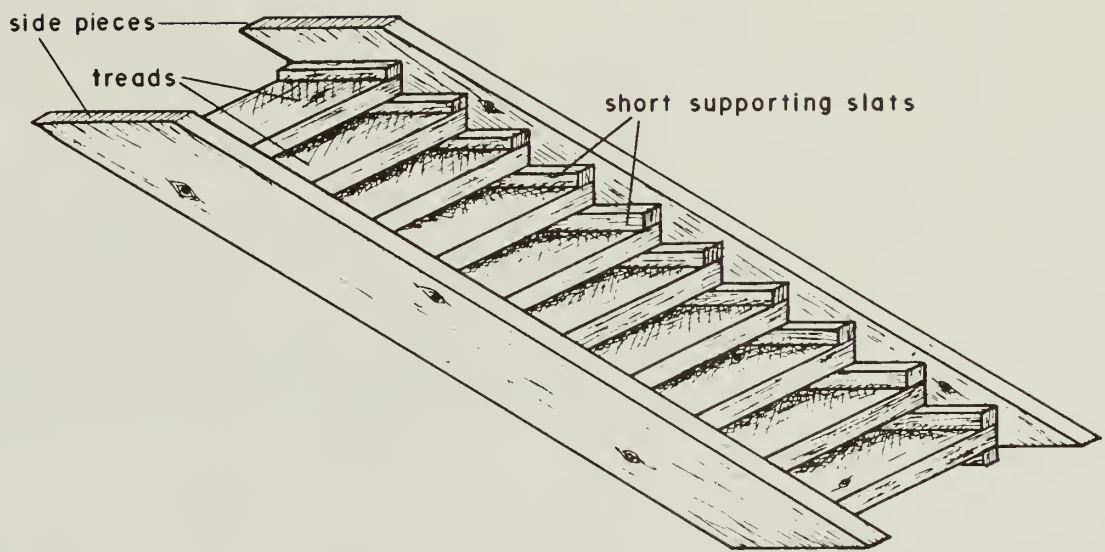
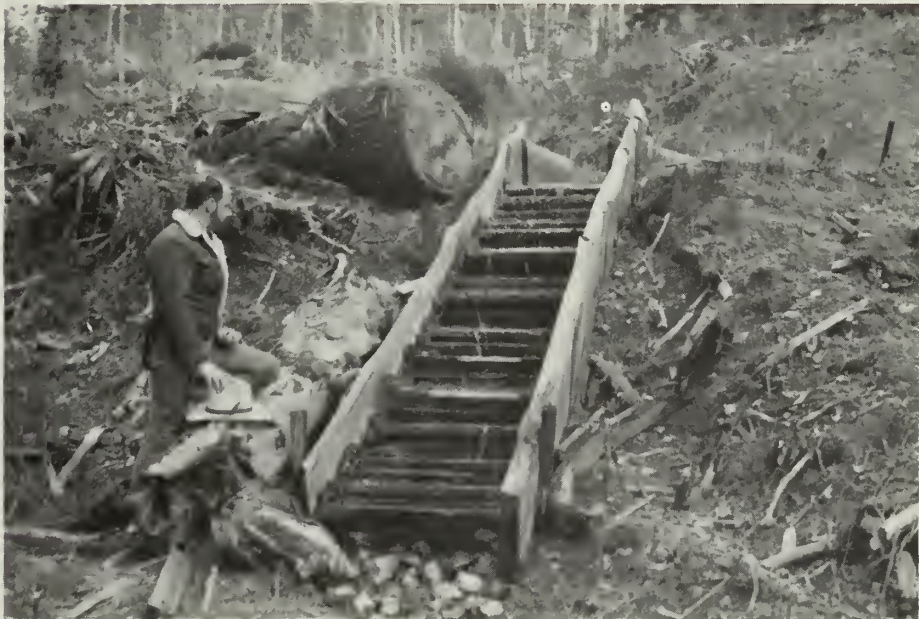
Figure 72: Type 4 Water Ladder

At Emerald Creek, four of five water ladders were Type 4 design (Figure 72). The fifth was a one-section waterflume.

All five were constructed at the downstream end of major crossroad drains. Wood for the ladders and flume was milled with an Alaskan Mill. Grooves (about 1/2 inch deep) were cut into the top side of the Type 4 ladder treads to direct flow towards the center of the ladder.

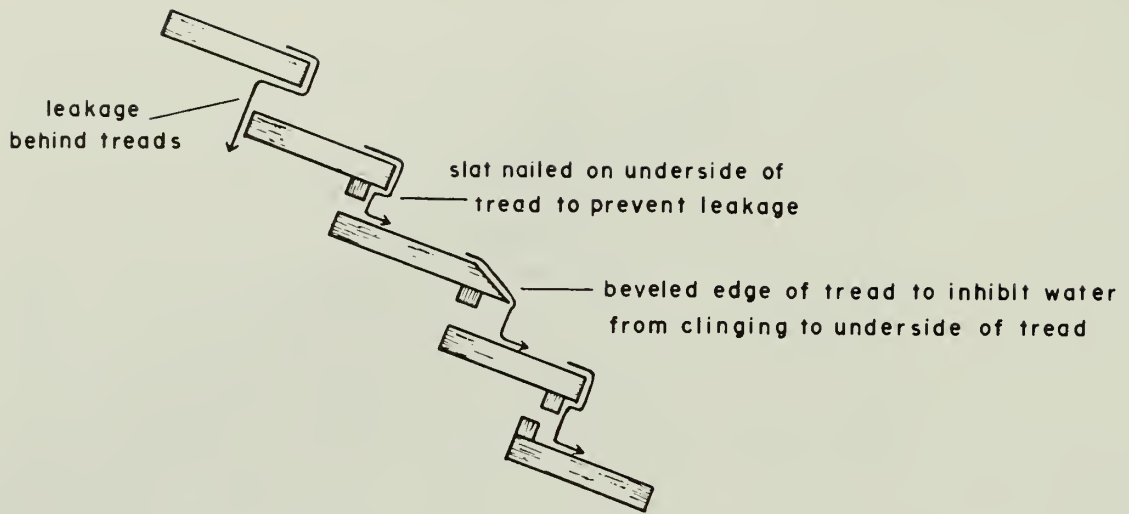
Figure 73: Side view of water ladder treads

At lowflow, Type 4 and other ladder types allow drops of water to go over the edge of the tread, cling to the bottom of the tread while moving upstream slightly, and finally drip down (Figure 73 - top tread). If tread overlap is not sufficient, the drops fall on unprotected soil and flow under the ladder. Slat of wood nailed under the treads prevent leakage from this source; cutting the downstream edge of the tread at an angle may also help (Figure 73).

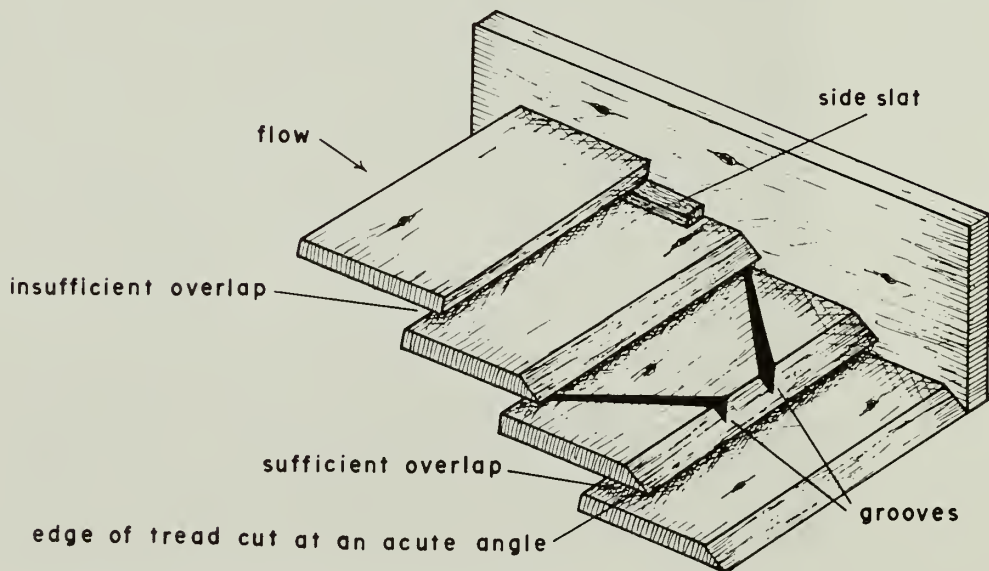
Figure 74: Oblique view of water ladder treads

Short slats nailed below treads parallel and adjacent to side pieces on Type 4 ladders seem to prevent side leakage (Figure 74) except when the slats extend beyond the downstream edge of the tread. In those cases, water flowed over the treads onto the slats and leaked between the slats and the side piece of the ladder.

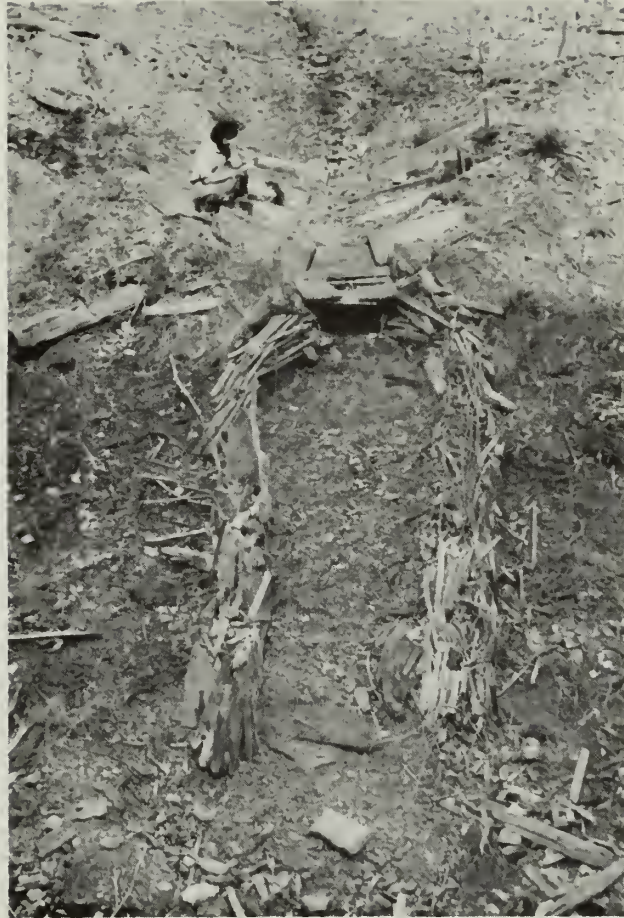
By September, 1978, a long gully had developed on the Bond Creek Unit (Figure 48), and a six foot knickpoint in the gully was beginning to migrate upslope. A gully plug installed at the knickpoint protected the headcut from further migration and erosion while conveying water across the sensitive area (Figure 75). In this respect the gully plug was used as an alternative to a water ladder in treating this erosional problem.

Figure 75: January, 1979
The gully plug on the Bond Creek Unit has collected a considerable amount of gravel and fine-grained material while protecting the headcut of the gully from migrating upstream. Three check dams with submerged spillways are located directly upstream of the gully plug (by the person in the photo) to prevent downcutting above the gully plug.

The gully carried heavy flows in winter and much sediment was transported to the gully plug. Fine particles ranging up to small gravel filtered through the chicken wire and were deposited in the debris below. Cobbles and large gravel were deposited and temporarily stored on the chicken wire or at the base of the gully. The gully plug was not designed to trap all sediment and some gravel will continue to be delivered to the stream channel below the gully plug.

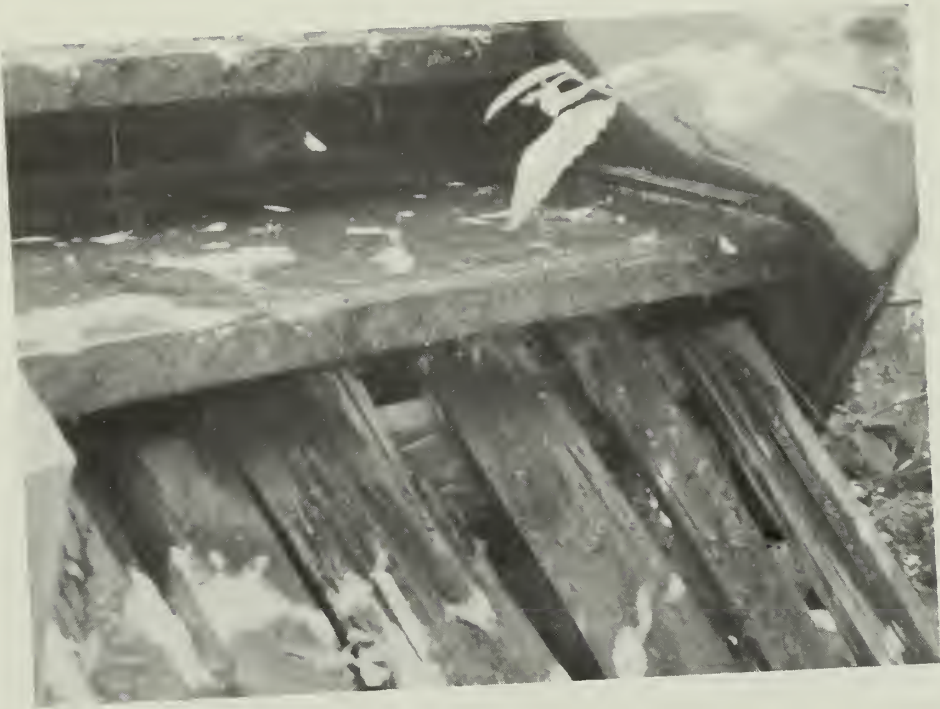
Figure 76. The 'grizzly' energy dissipator below a water ladder. Large rocks were placed under the slats of wood as well.

Water from the ladder drips down the slats or trickles through to the rocks below. No signs of undercutting are visible (Figure 76).

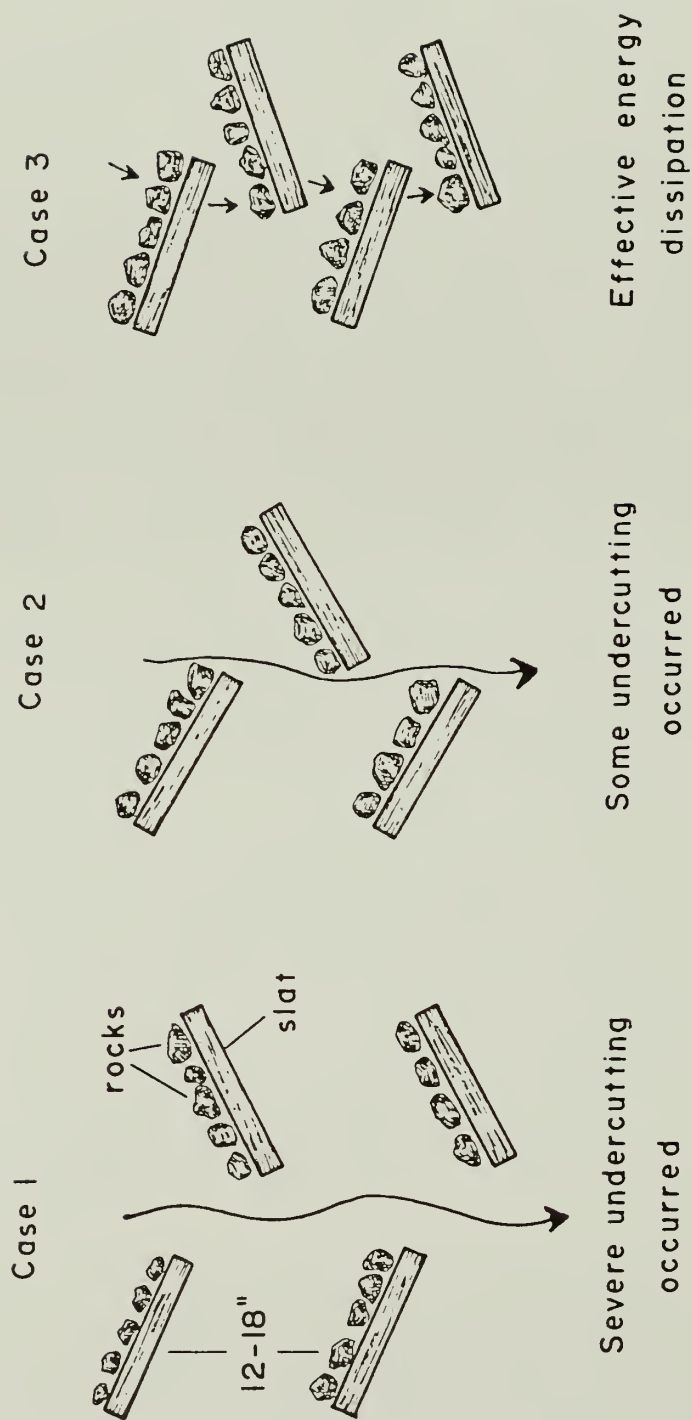
Figure 77: Design of herringbone energy dissipators.

Another form of energy dissipation is a herringbone pattern of redwood slats staked into the ground and backfilled with rocks. Some slats were undercut by winter flows; others worked well. Success of the slats seems to depend on the pattern in which they are set (Figure 77). Alternating slats must overlap four to six inches and be fairly close together in order to effectively handle flows and minimize downcutting (Figure 78). Rocks upstream of the redwood slats protect slats from the scouring action of unimpeded flow. Even with sufficient overlap herring bone dissipators do not prevent downcutting in the channel. They should not be used in place of a water ladder or check dams to prevent erosion in an area where downcutting is expected.

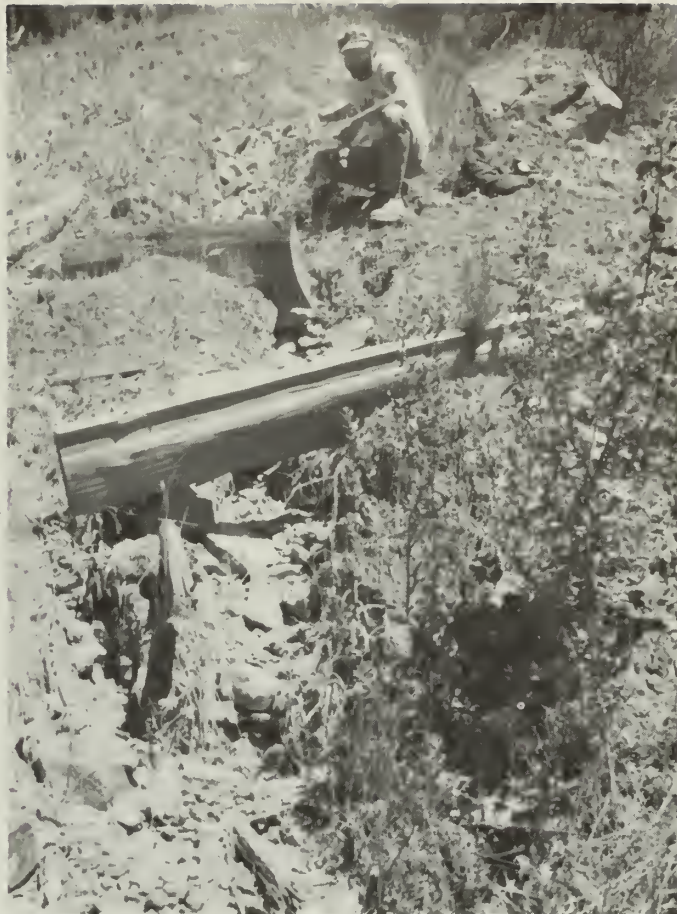
Figure 78: Emerald Creek
Herringbone energy dissipator
below cross road drain has
been undercut. In this case,
the distance between boards
was too large, and the
upstream sides of the slats
were not protected by rocks.

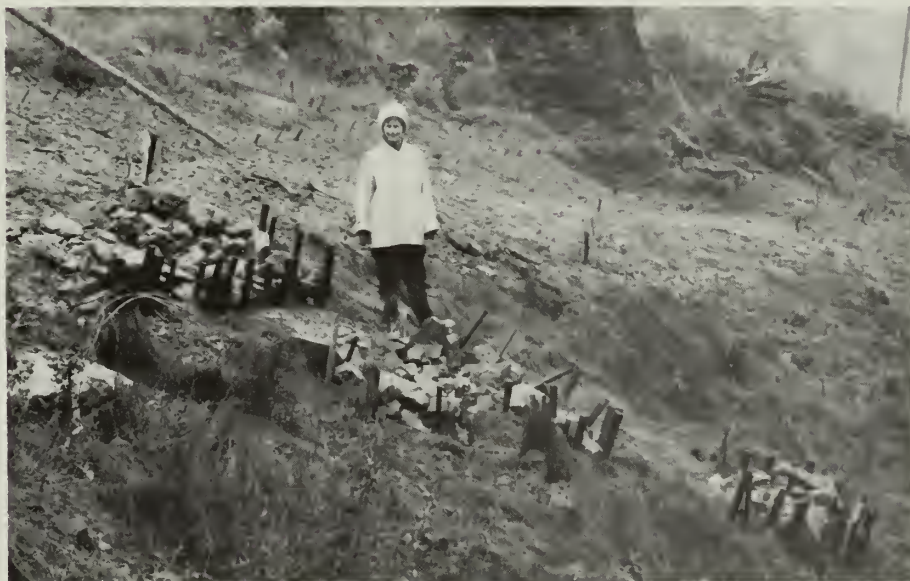
Successive piles of rock held in place by redwood stakes in the channel is another type of energy dissipator (Figure 79). This dissipator did not receive much flow, so its efficiency was not rigorously tested. Nevertheless, the dissipator did handle low-to-intermediate flows well, and no signs of undercutting are evident. More testing of all types of dissipators under high flow conditions is necessary.

Figure 79: Emerald Creek CRD 15
Piles of rock anchored to the slope below a cross road
drain, filter runoff through them and dissipate erosive
energy.

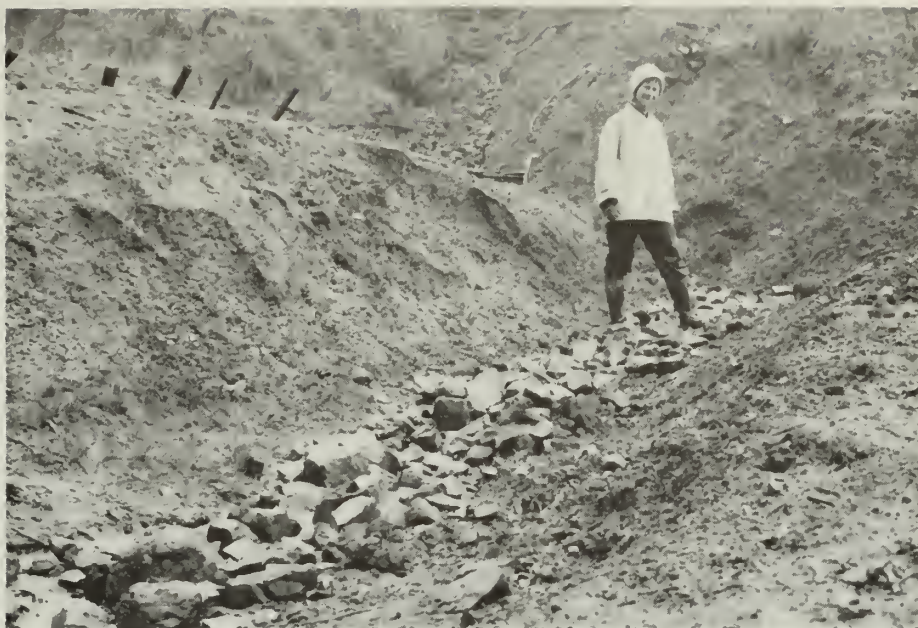
On Emerald Creek, manually placing large rocks (greater than four inches in diameter) in the crossroad drain channels protected the drains from downcutting. Because the lower three-quarters of the former C-90 Road had been rocked, a plentiful supply of suitable rocks was available. Over the winter, fine sediment settled in between the rocks, tightly packing them together, and armoring the channel bed (Figures 80 and 81).

Figure 80: Manually-placed coarse rock on the bed of a cross road drain prevents downcutting of the channel bed while allowing unhindered flow of runoff through the drain.

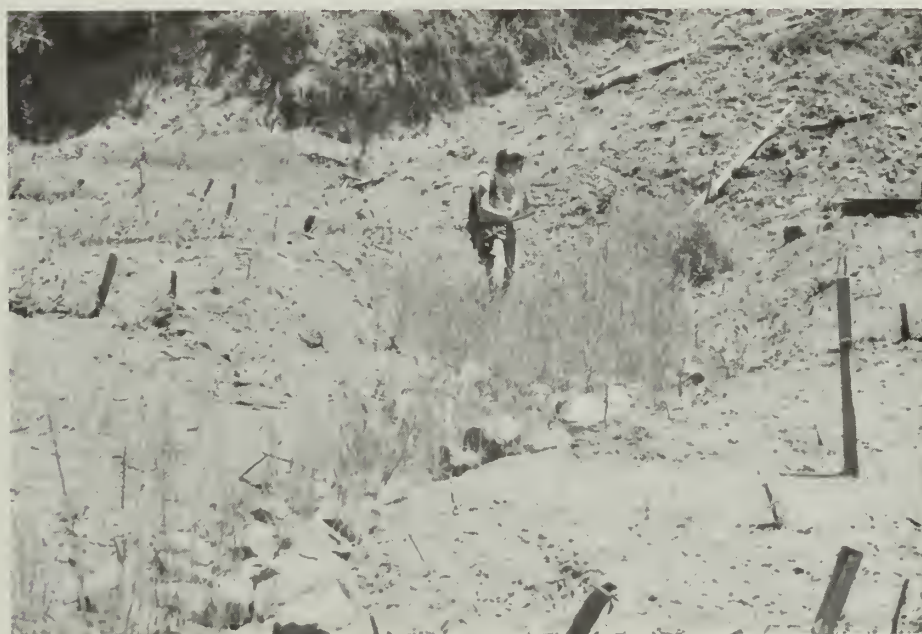
Figure 81: A thick stand of grass in a moist cross road drain adds support to the banks by its dense root mass. The grass and rocks trap fine soil particles that would otherwise be washed downstream.

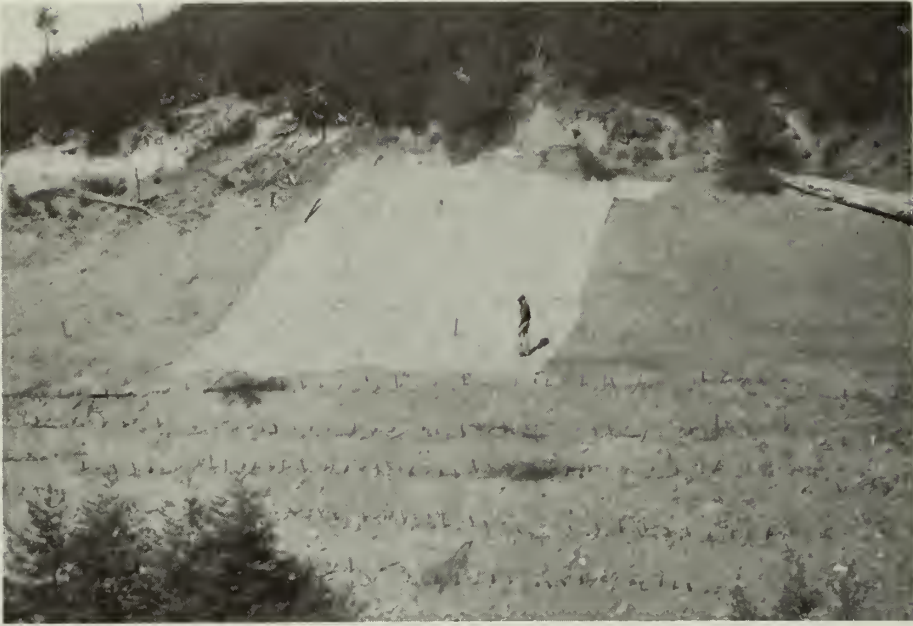
Three types of mulches were used on portions of the outsloped road in Upper Miller Creek, redwood chips, straw, and jute netting (see Figures 82, 83, 84). Mulched slopes (7700 square feet in all) were composed of the same soil material and had similar gradients (20 to 30%). Mulches were spread by hand, and cuttings of willow and other species were planted through the mulch to secure it to the slope.

In general, mulches have shifted slightly downslope over the winter, but little movement of large soil particles has occurred. In June the ground under the mulches (especially the redwood chip mulch) was moist, while on the control sites the soil was dry. Mulches prevented some rockfall from upslope from continuing downslope onto wattled areas. Mulches (especially the straw) also intercepted and dispersed rills originating upslope.

Figure 82: Redwood chip and brush mulch was spread on the outsloped road and Miller Creek, and was then covered with jute netting.

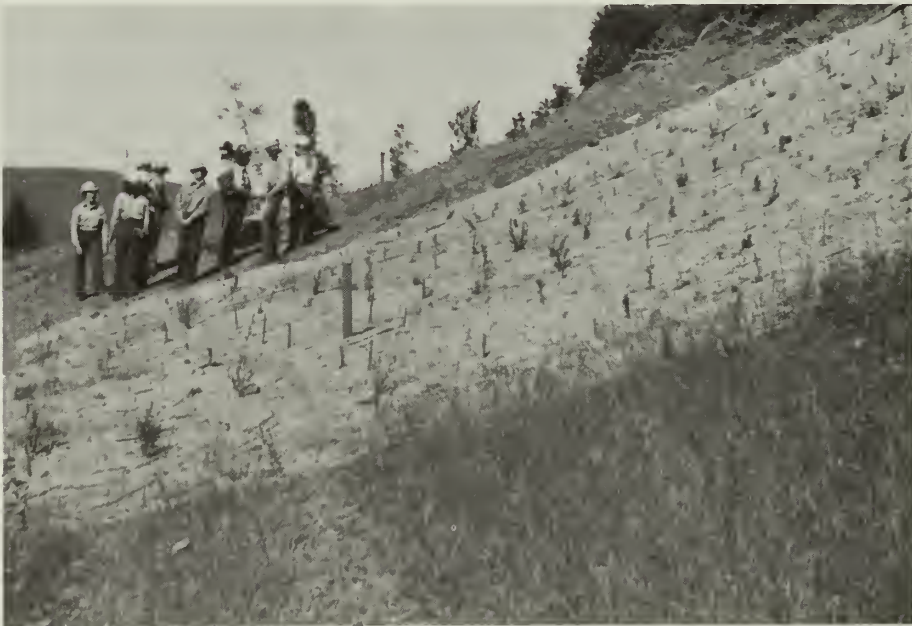
Jute netting without an under-layer of mulch was used on a steeper, rockier slope. The planter box directly below the jute netting was the only one on that slope that did not fill with dry ravel and rockfall over the winter months. Thus, jute netting seems to inhibit the downslope movement of soil particles which would otherwise be susceptible to dry ravel.

Figure 83: A close-up view at Miller Creek of the jute netting showing the stem cuttings which were used to secure the netting to the slope.

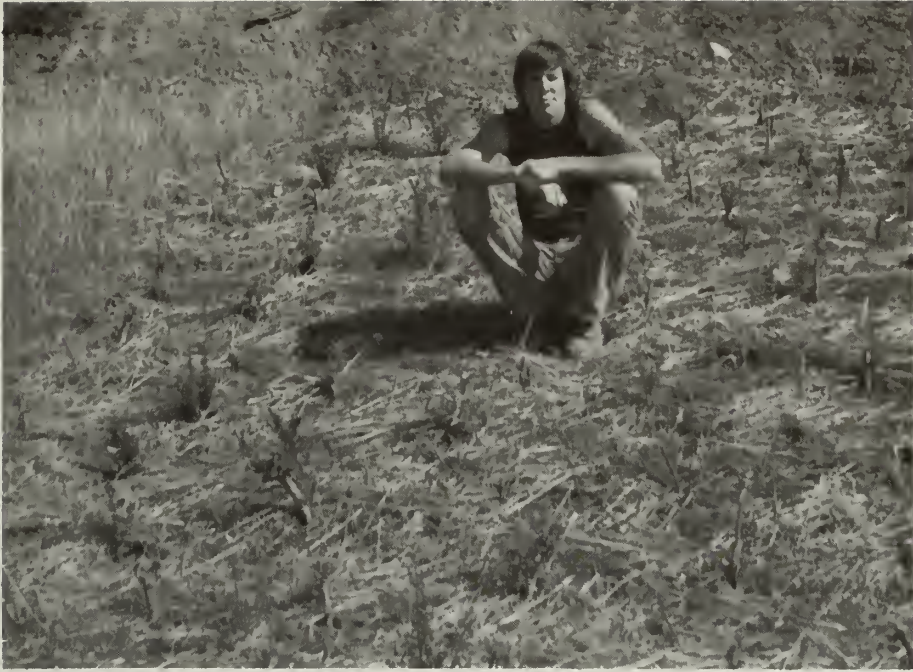
Figure 84: A close-up view of straw mulch and stem cuttings at Miller Creek Unit.
